Rebuilding a Stewart Warner "Schubert"

Gord Rabjohn, December/January 2022/23

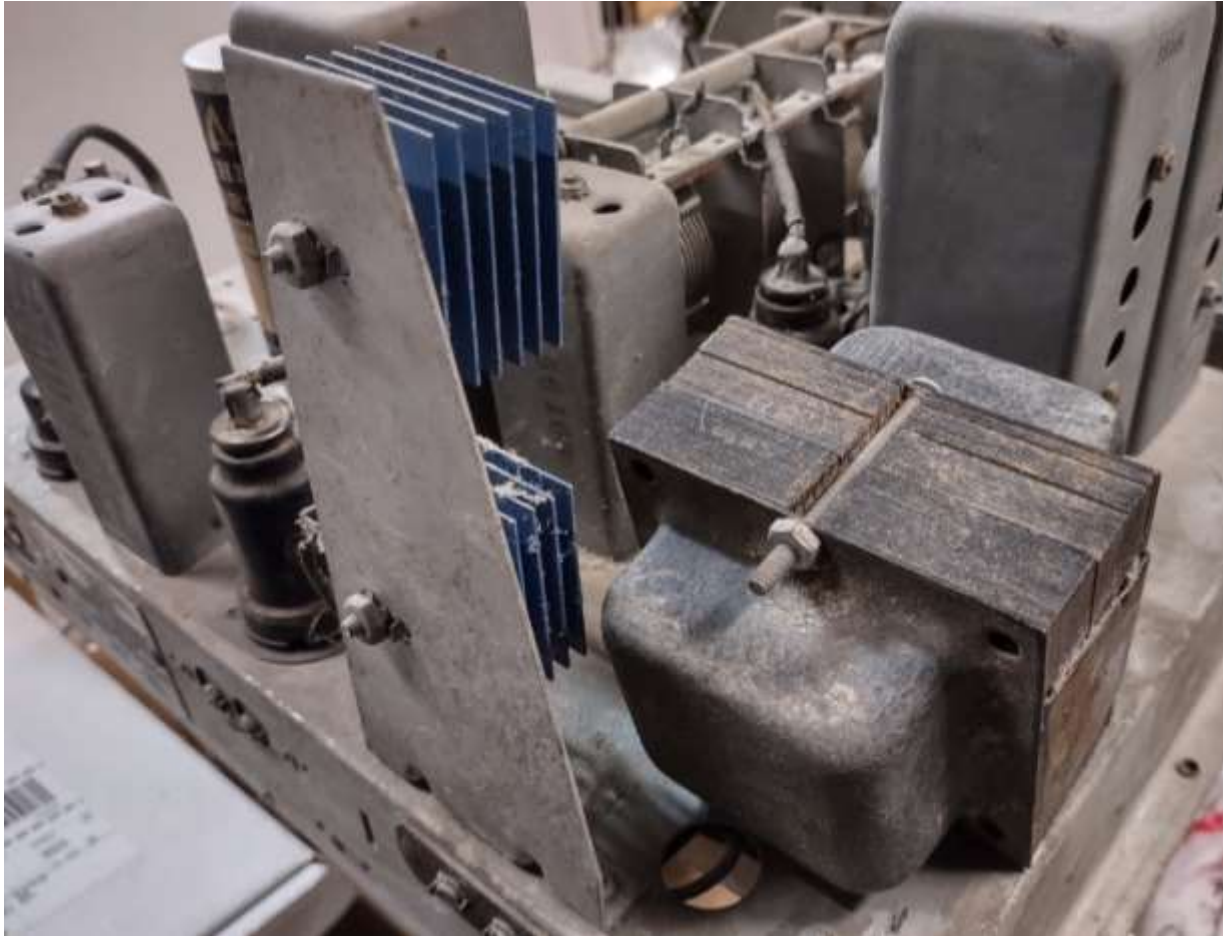
Figure 2: Corner of Chassis with Innovative Power Supply

When I received the radio and compared it to the circuit diagram, I was fascinated and a bit frightened to see that the original power transformer and rectifier (which had been a very standard configuration) had been replaced. The filaments were supplied by a dedicated 6V filament transformer. The B+ was generated with a selenium rectifier voltage doubler (with each selenium rectifier shunted by a silicon diode), directly from the line voltage! Which means that one side of the AC line was tied to the chassis. I assume that the power transformer burnt out at some time in the past, and a repair person with more creativity than common sense did not want to pay for the correct replacement transformer, and opted instead to use whatever he had in his junk box.

Now, I never like radios with the line tied to the chassis, though that was common practice in the early days of AC-DC sets. It is, of course, an electrical safety issue. But, respectable AC-DC sets took great pains to make sure the chassis was never exposed: they used knobs without set-screws, mounting screws were insulated with bushings, and the chassis was protected with an insulated cabinet on all sides. However, none of these precautions would have been taken with this Stewart-Warner. So, I decided that the creative repair had to go, and I would need to find an appropriate transformer so that I could restore the original circuitry.

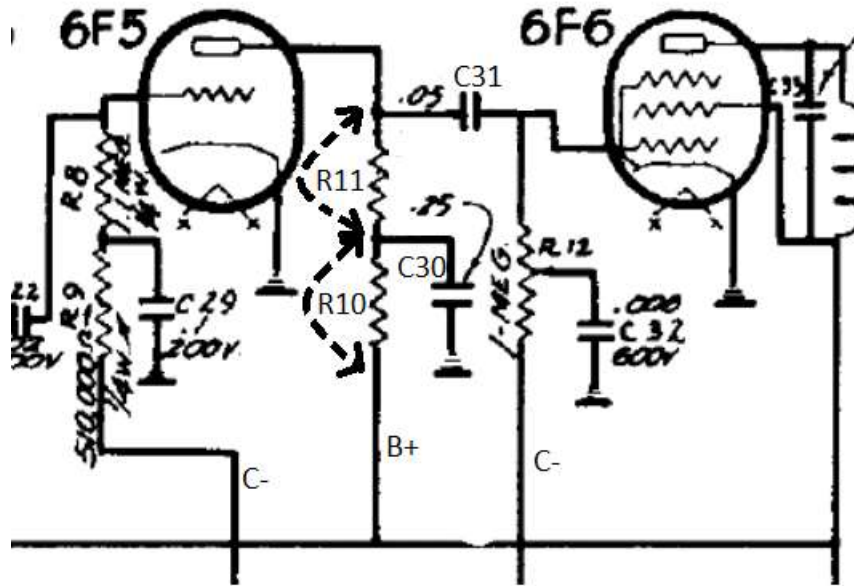
Figure 3 Schematic of Audio Section of Radio

For example, consider the schematic of the audio amplifier. With the 6F5 and 6F6 tubes removed (or filaments not energised), the DC current thru R10 and R11 should be zero. If it is not, then C30 (the decoupling capacitor) or C31 (the coupling capacitor to the grid of the 6F6) is leaky. C31 is especially critical, because if it is leaky, then the 6F6 grid bias will be too high, the 6F6 will run too “hard”, and it could burn out prematurely. Measure the voltage across these 2 resistors (as shown with the dotted lines) with the filaments off or tubes removed. If it is not zero (let's say less than a half a volt), then replace C30 and/or C31. There are several places in the radio where this test can be done; the B+ for the screen grids of the RF tubes, and the AGC line, for example.

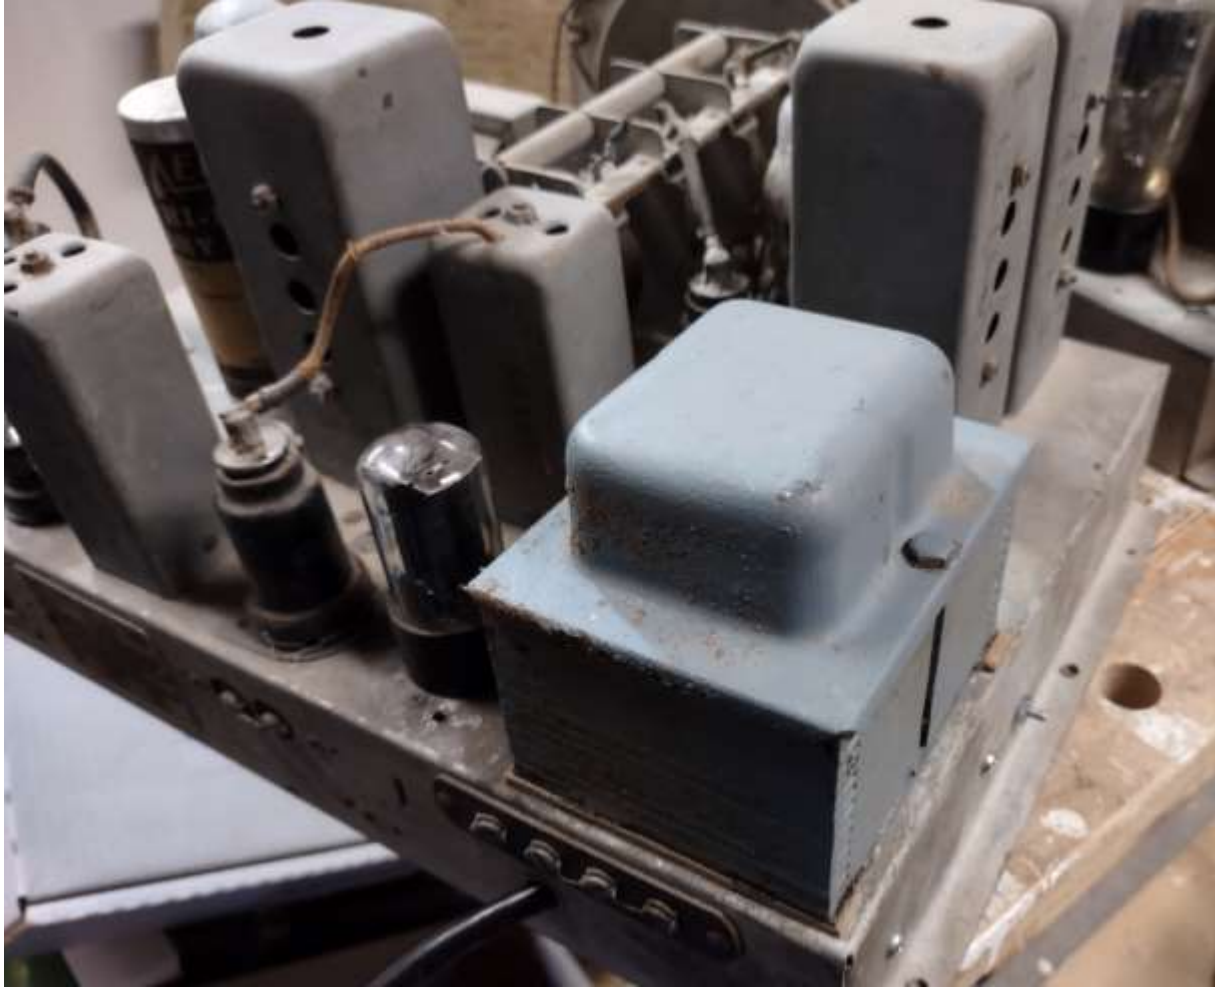
Figure 4 Chassis with new power transformer installed.

Having replaced the most obvious capacitors, I proceeded to work on mounting the “new” power transformer. The original transformer was mounted entirely above the chassis, but the only appropriate transformer I had required a large square hole in the chassis. I cut said hole with a Dremel tool heavy-duty cut-off wheel. Even though the transformer is not the correct style for this radio, it is properly and securely mounted, and “looks” correct. I restored the original 5Y3GT rectifier and other power supply components (it now matches the published schematic), and installed a 3-prong cord and a fuse. I replaced some wires that had degrading insulation, including the wires to the speaker and dial lamps.

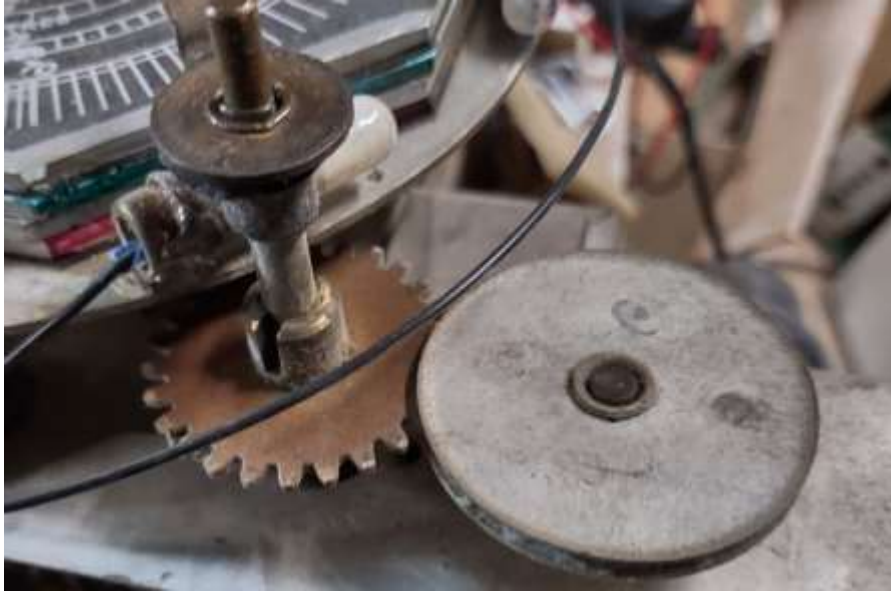
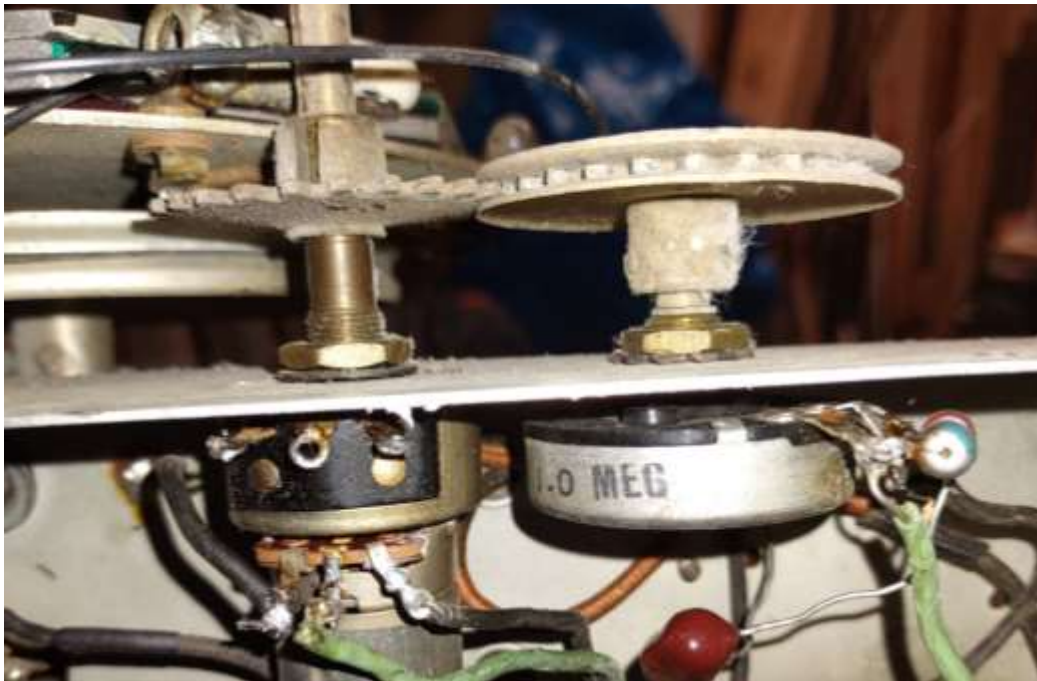
The tone control is a mystery to me! The tone control's shaft is concentric with the volume/on/off control, as is common in receivers of this vintage. However, the tone control resistance unit that is concentric with the volume control has been disconnected (and is the wrong value anyway, I suspect that this was another junk-box find). Instead, a fibre gear links the outside shaft to a separate tone control. It appears to me that the repair guy who was creative with the selenium rectifier was also creative with his tone control replacement! However, it is professionally done, so I left it.

Figure 5 Tone Control Kluge
