Repairing a Philco Tombstone.

Gord Rabjohn
February 2025

I was given a Philco model 37-620 (1937) tombstone to repair. This is a nice looking 6-tube 3-band radio.

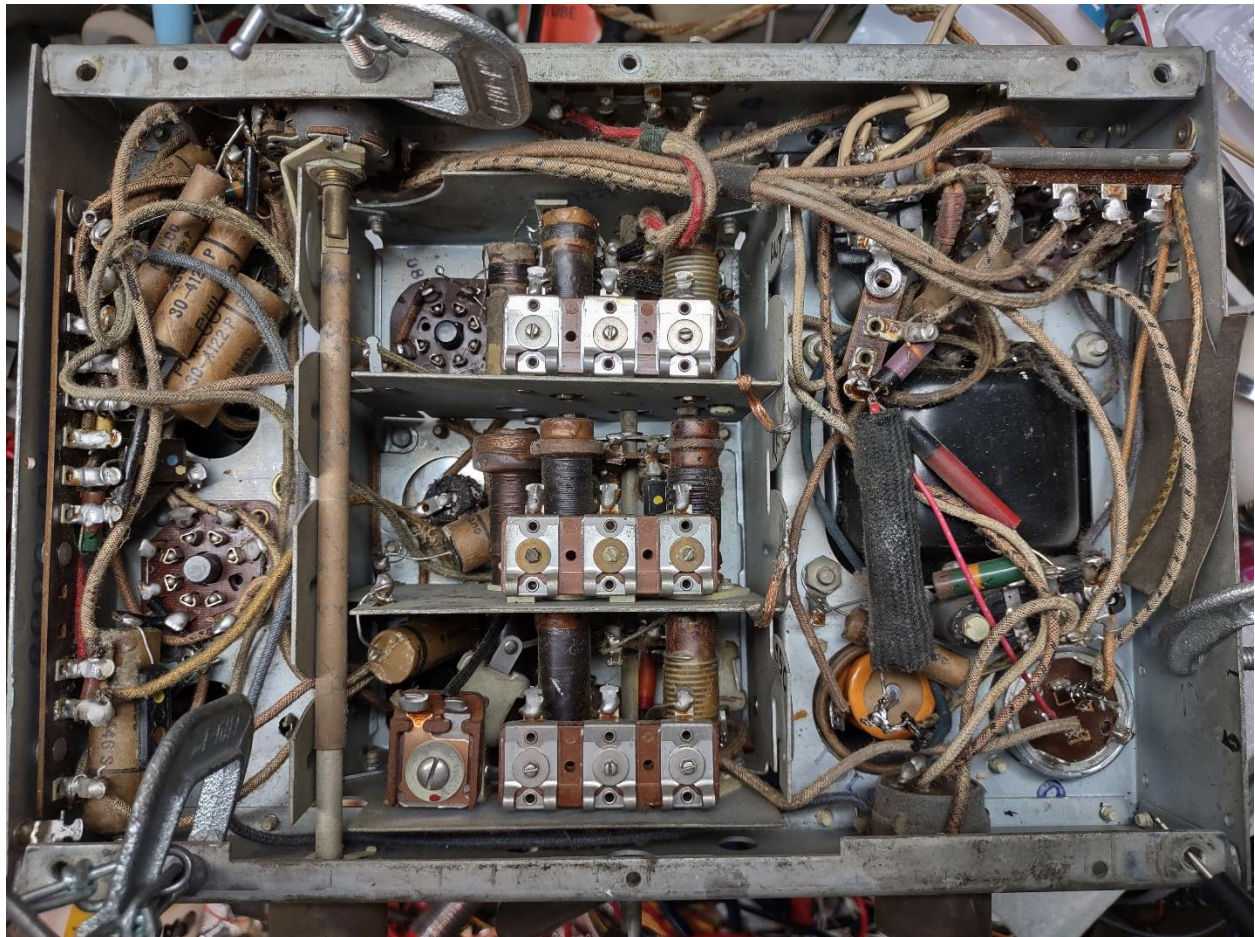
After giving it a visual inspection, I turned it on with a 100W bulb in series with the line. It came to life weakly with hum, and the bulb barely lit, all good. As is the case in most radios of this vintage, the power supply capacitors needed changing. The original “wet” electrolytics were still present, one was shunted with a more modern capacitor; the radio had seen very little servicing in the past. I tested the ESR of the capacitors, and all of them were pretty much open. (The Equivalent Series Resistance (ESR) test was a formality. Wet electrolytic capacitors of this age will always be defective, and I will always replace them). I replaced one with a more modern (but physically similar) multi-section capacitor, and hid another in the empty shell of one of the original capacitors. Below is the chassis with the capacitors replaced.

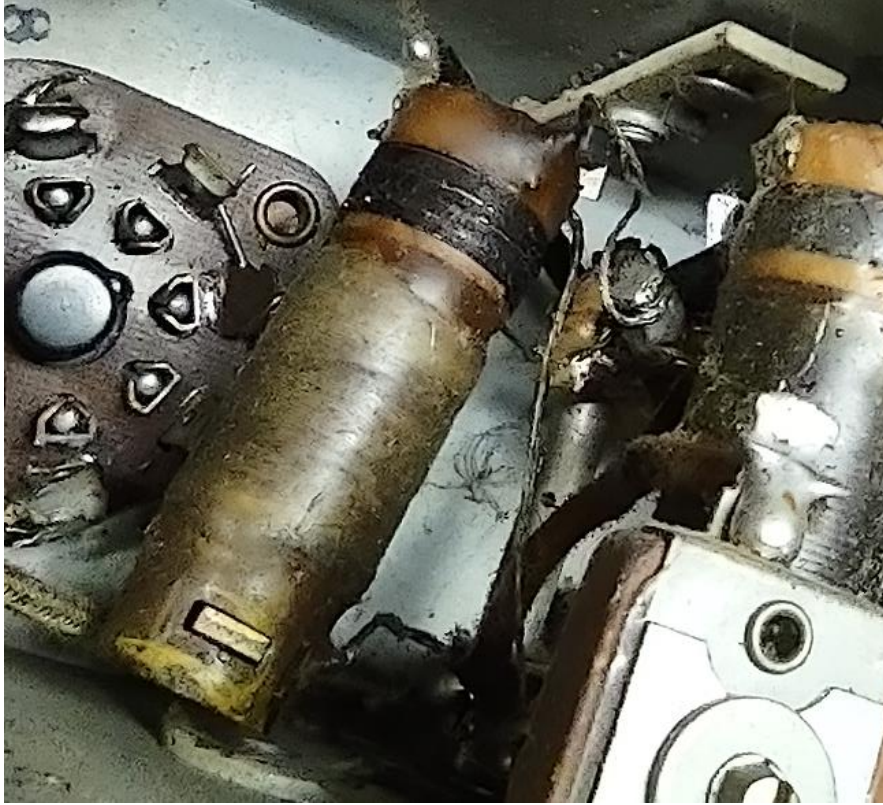
This brought some life back to the radio. I connected an antenna, and some AM stations came in weakly, but short-wave was quite active. Even with a long antenna, the AVC voltage on a local station was barely -1V (I mention the value of the AGC voltage as a gauge to the health of a radio in the Spring 2024 OVRC newsletter). Something was killing ONLY the AM band. This generally narrows it down to some part close to the band switch. I had noticed earlier that one of the antenna coils did not look “right”. You can see in the photo below that the upper end of the coil is dark and shiny, where the rest of the coil is lighter and dull. This is an indication that the winding has overheated and the wax has melted, something that should never happen to a coil like this.

This was the AM antenna coil that connects, through the band selection switch, to the antenna terminals at the back of the radio. I measured the resistance of this coil, and it was an open circuit; it should be a low resistance. The short-wave antenna coils were low resistance as they should be. If I hadn't noticed the discolouration, I'm not sure I'd ever have found this fault!

I rewound the coil with #36 magnet wire (scavenged from a colour TV deflection magnet). It required 30 turns close-wound (with a centre tap), so not too difficult to wind by hand. The other “secondary” winding was intact. Reinstalling the coil was another adventure, and I ended up supporting it by its leads.

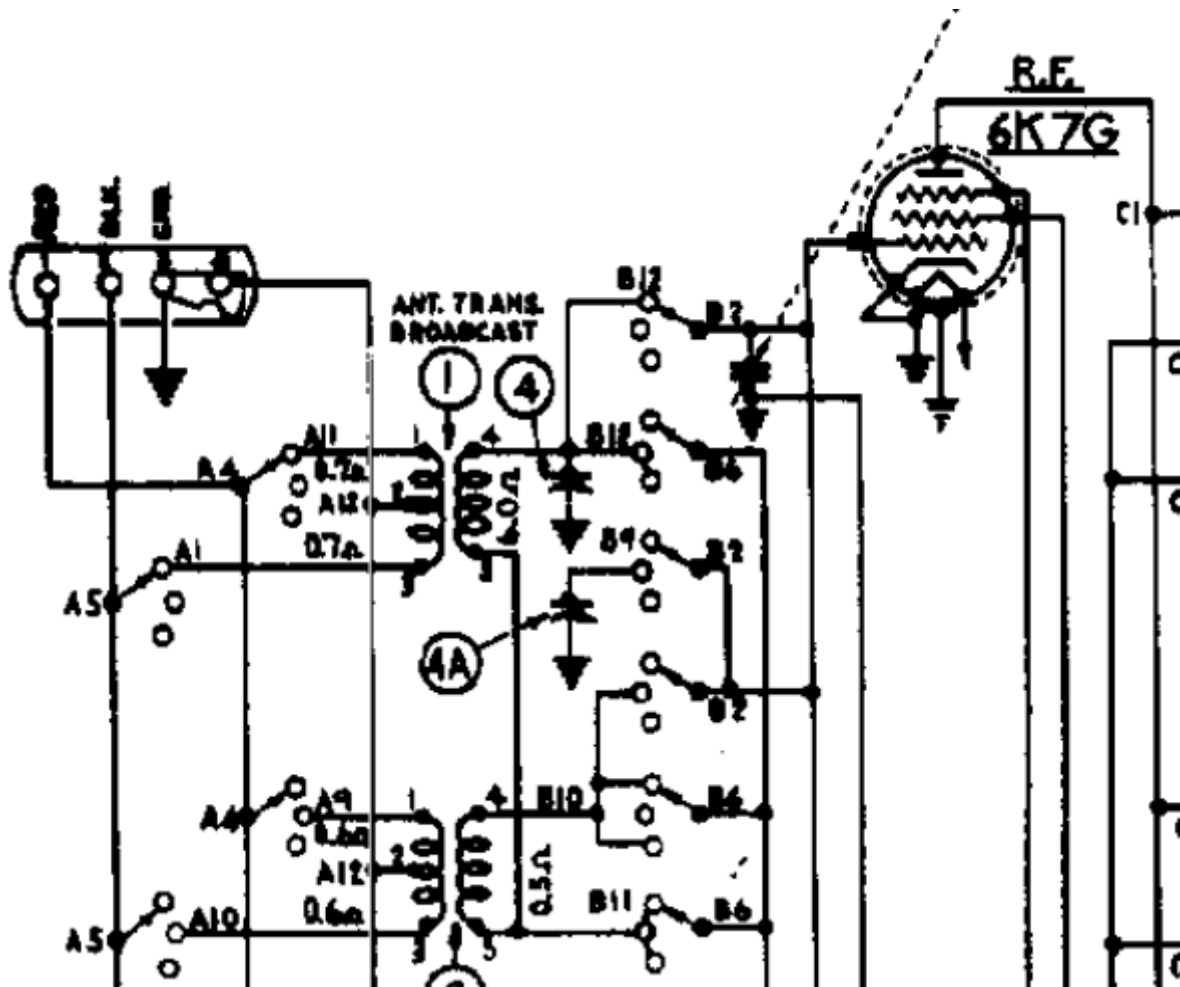
This radio is well built with many small compartments dividing apart the various functions for the radio. Unfortunately, it makes it very difficult to work on, because many of the components are deep in caverns. It was a challenge getting the coil out. I removed it and looked at the windings under a microscope. Balls of formerly molten copper were visible, confirming my suspicion that this coil had seen way too much current.

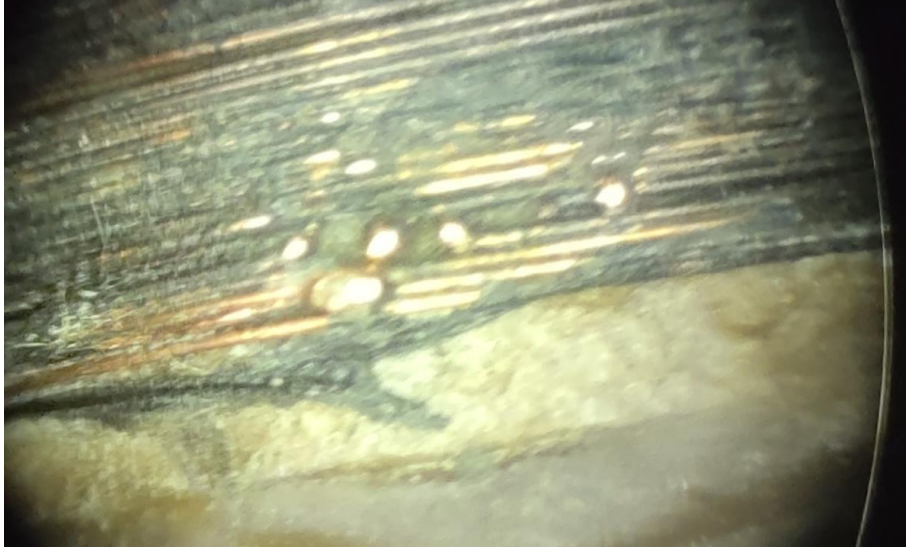
It is worth considering how this damage could have happened. A lightning strike nearby could have done it. A direct strike would have caused much more damage unless there was a good lightning arrester on the antenna. Possibly the antenna touched a live wire. Another possibility is that the chassis of the radio was live (due to a damaged power transformer or line capacitor), and the antenna touched an external ground. However, I checked the capacitors and transformer and leakage was minimal.
