Repairing a Stewart Warner "King"

Gord Rabjohn, February 2023

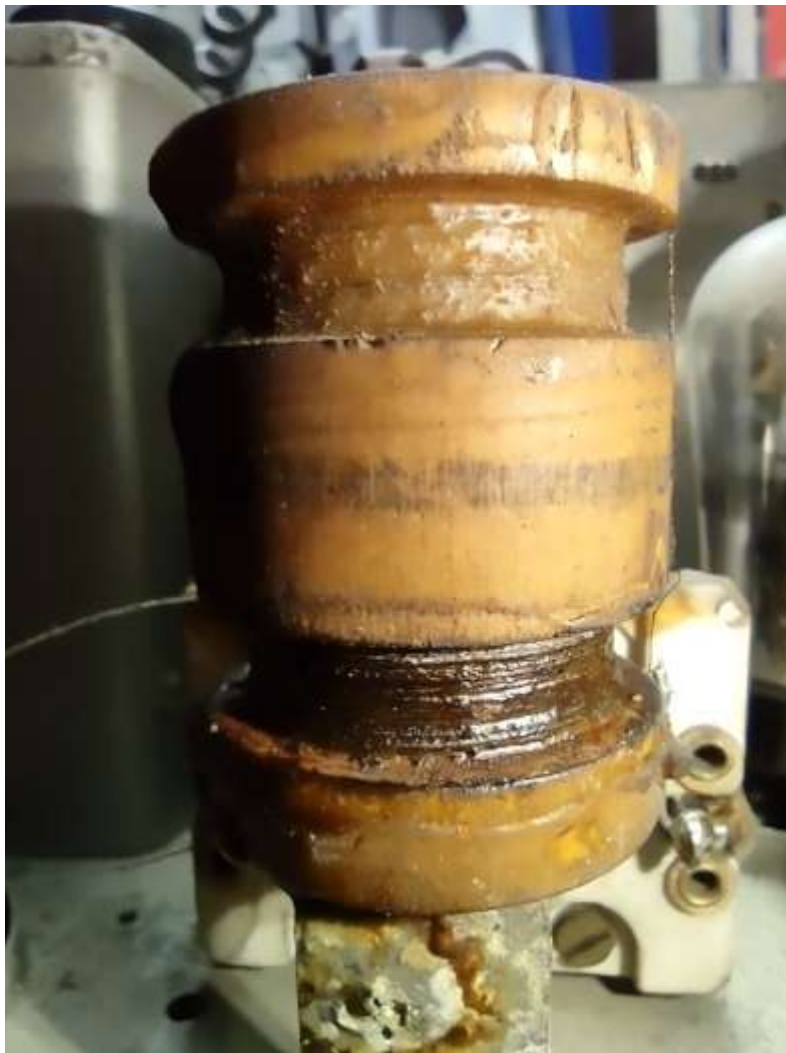
I checked tube voltages, and found that the IF stage had no plate voltage. This usually means that the associated IF transformer is burnt out, and I verified this by measuring the winding's resistance (it was an open circuit). This early radio uses an unusual IF frequency of 177.5kHz. I opened the IF can and found a wooden spool with two windings secured with wax; the dead winding was darker as the wax

Figure 2 IF transformer before repair

had melted. I unwound the dead coil (finding at least 3 breaks or weak spots), counting the carefully wound uniform windings, which added up to about 950 turns! (I was not expecting that many turns, but the lower-than-usual IF frequency means that more-than-the-usual turns would be required). The original winding used thin (0.003") wire wrapped with cotton insulation, but all I had was enamelled #32 copper "magnet" wire. The outside diameter was almost the same so I used it; my wire offered more copper, less insulation. I was unable to wind it in neat well-organized flat solenoid layers. The technical term for my technique is "Scramble" winding. The finished coil had about the right inductance (measured at 14mH), and had much lower DC resistance, but I was surprised to discover the "Q" of my coil at 200kHz was about half of the other (similar inductance) winding. I attribute the difference to the close proximity between windings (because of the thin enamel insulation) causing current crowding. This is why high "Q" coils are made with "Litz" wire and have wide turn-turn spacing. In principle, the lower Q meant that the IF bandwidth might be a little wider, but there were still 3 other resonant circuits in the IF, so the difference would not be noticeable.

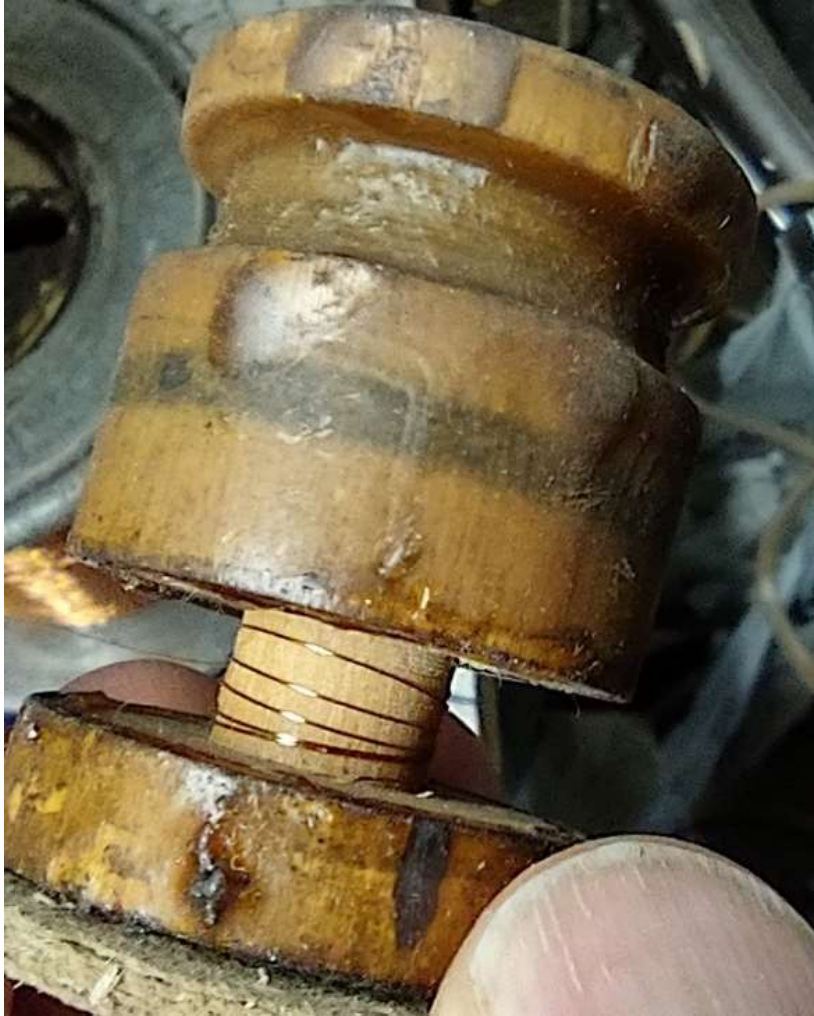
Figure 3 IF transformer with one winding removed

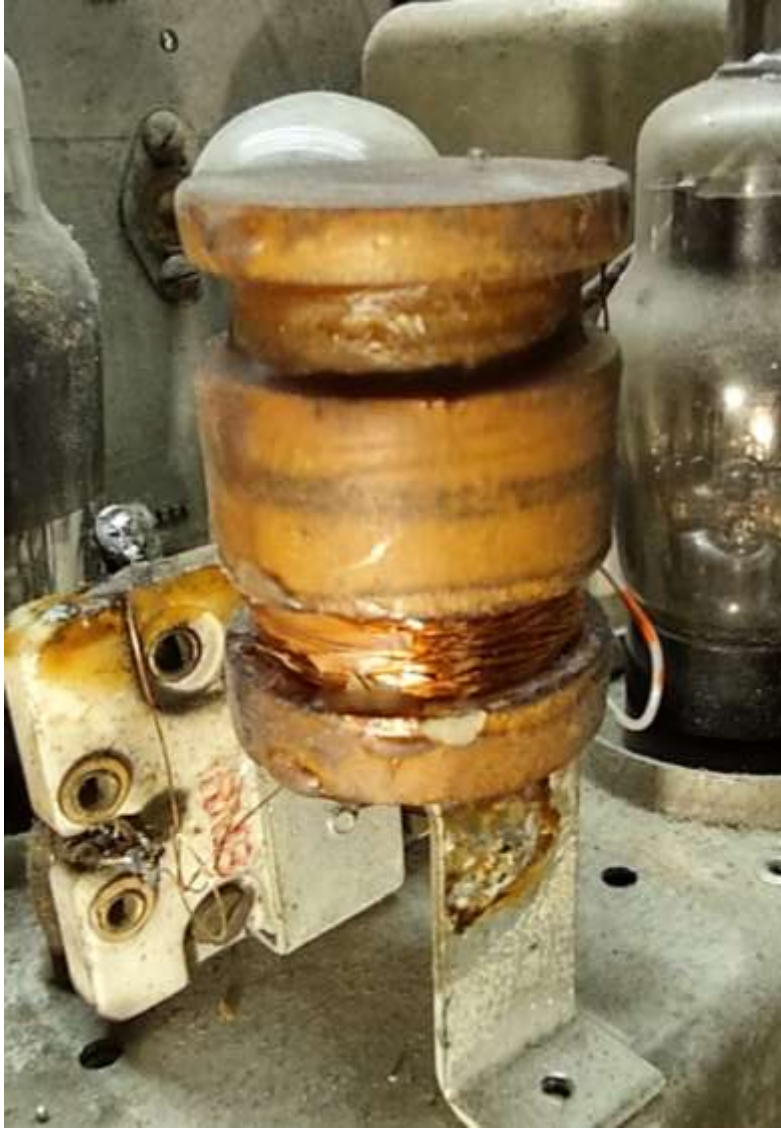
Figure 4 Rewound IF transformer

The repaired IF transformer brought the radio back to life. However, with a new IF transformer winding, an IF alignment was essential. When I adjusted the IF trimmer capacitor with a metal screwdriver, I was literally shocked to discover that the adjustment screws (on the input side of each transformer) are connected directly to the 300V B+. And, the screw is quite close to the grounded bracket, so sparks fly if you slip. The trimmer is quite hard to turn, so my plastic alignment tool was not strong enough. I managed to get it aligned, but I want to share this warning: *When aligning a radio, do not trust that the adjustment screws are at a safe voltage, even in a radio with a good power transformer. 300V grabs your attention and could be lethal!*
