Repairing an Odd Sparton

Gord Rabjohn

August 2025

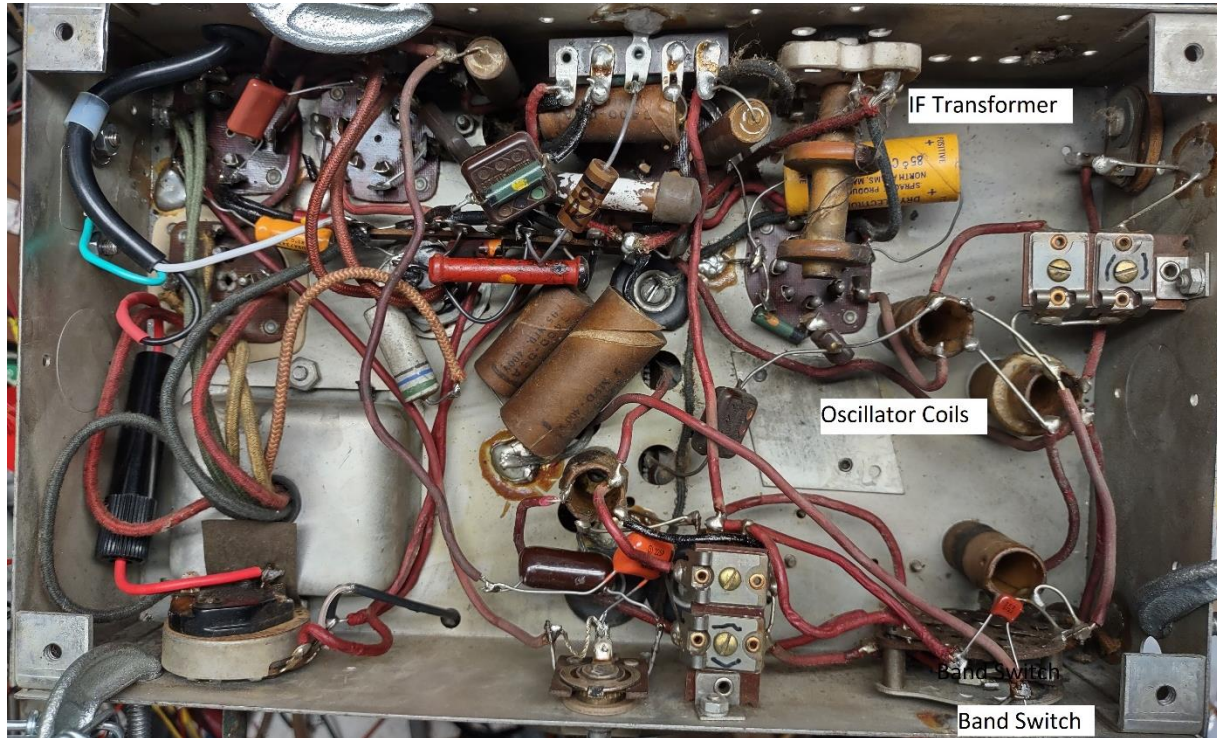
Figure 2 The underside of the Sparton.

I looked for the cause of this oscillation. I verified that the tube shields were in place. I shunted every decoupling capacitor with a known good capacitor but the oscillation remained. I shorted the IF transformer, and it made little difference. As I was looking into this radio, I noticed some unusual features: The first IF transformer is unshielded and located under the chassis, not far from the other coils. In most radios, this transformer would be well shielded and mounted on top of the chassis. Also, the band switch is unusually simple. Often, band switches in radios like this employ multiple wafers with complex switching schemes. This one has a simple one-wafer "4 pole triple throw" switch. Another odd feature: it uses a 3-gang tuning capacitor, which is usually only seen in radios with an RF amplifier; this radio does not have an RF amplifier.

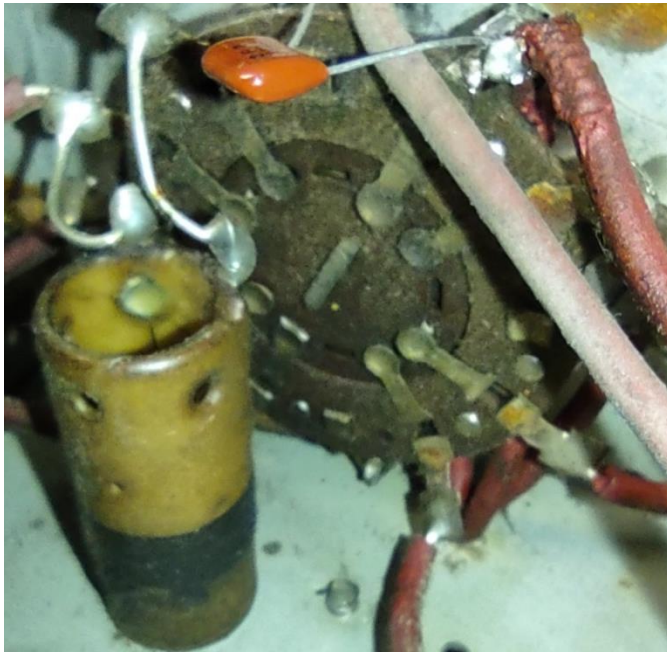
Figure 3 The simple band switch.

Multiband radios need different RF and LO coils for each band. Most multi-band radios use a complex switching arrangement that shorts out (or otherwise disables) unused coils. If left open, a coil can resonate. A high Q resonating coil can easily couple to other coils and cause "suck-outs" over narrow frequencies. (If you have ever used a grid-dip meter, you will have observed this) A resonant coil can cause resonances in other coils that can cause rapid changes in impedance over frequency, and one of these impedances can create the condition for oscillation. I traced the schematic of this Sparton, and indeed some BC coils are left connected in the circuit when the radio is switched to shortwave. (The triple-gang tuning capacitor is used in a complex double-tuned antenna circuit that requires more coils than usual) I believe that these unused coils, and perhaps the unshielded IF transformer, are coupling to each other or causing unwanted coupling that leads to oscillation. Detuning ("dumbing down") the shortwave antenna circuit tames the radio. This is an arm-waving explanation at best, but I tried everything else. Explaining the oscillation more precisely would be difficult (and would probably require that the radio be dismantled and reassembled).

The solution to my oscillating radio problem appeared in the radio's documentation. The alignment instructions from RCC included the phrase: *"Adjust the RF trimmer to point of greatest output. The trimmer should be turned a very small amount (1/16 of a turn) to the right to increase capacity slightly"*. When I did this, the oscillation stopped, and the radio worked well. So, what gives?
