Repairing a Haunted Philco Model 70 Console

Gord Rabjohn, Halloween, 2020

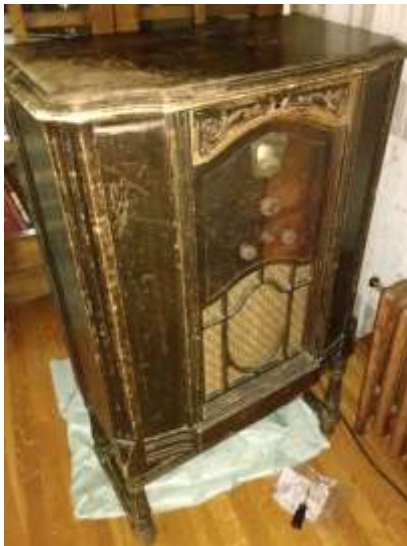
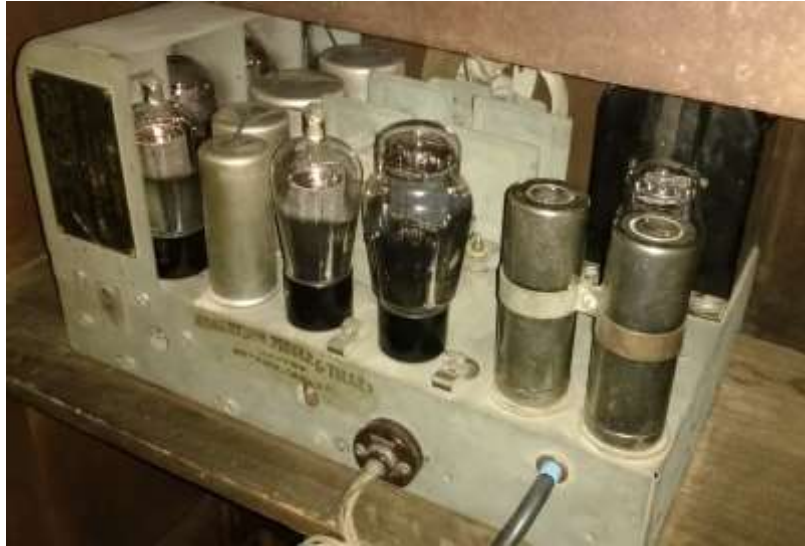
The radio after electrical restoration

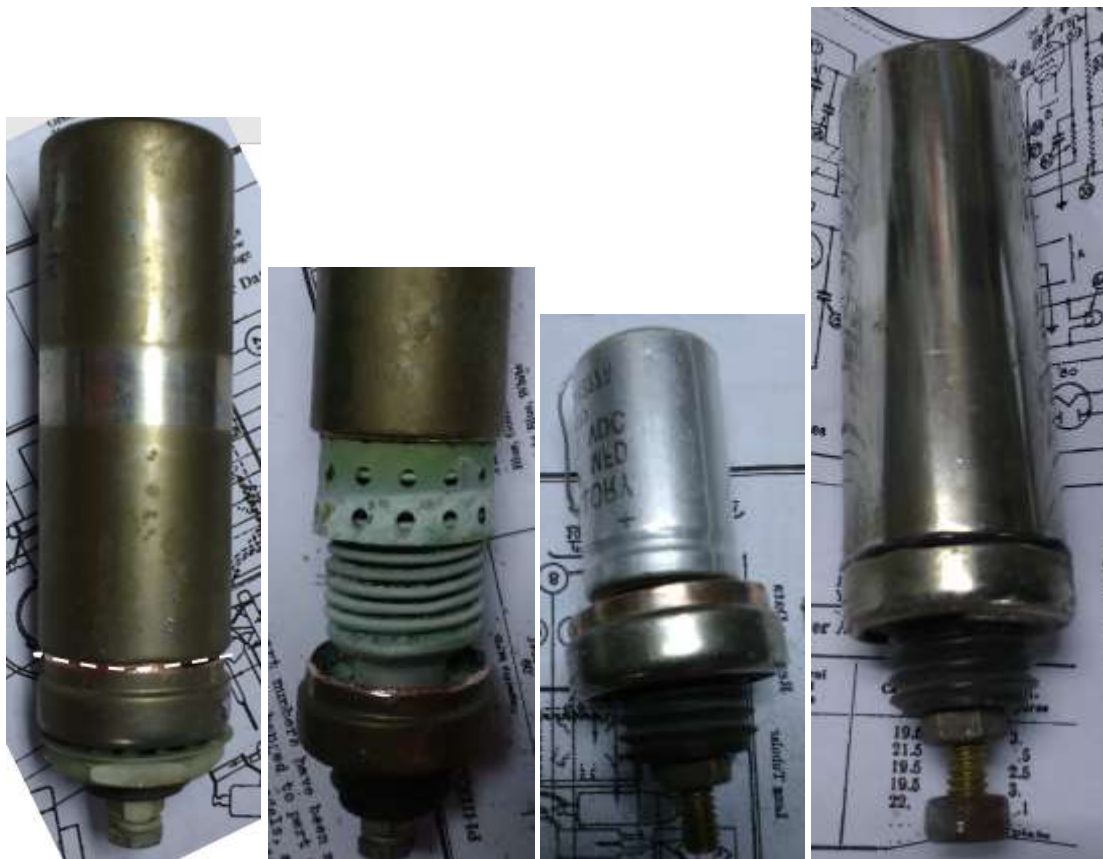
The restoration of the electrolytic capacitor: before, old guts, new guts, and after.

The electrolytic capacitors were sliced open (along the dashed line in the figure) and the contents were removed. By slicing the can at the top of the indent, the top can be reassembled over the bottom with a little overlap. The positive terminal is simply a bolt attached to the internal positive electrode. With some physical encouragement, this assembly can be replaced with a brass bolt, and connected to the positive terminal of the modern capacitor. The negative terminal is soldered to the base. The can is very neatly reassembled with epoxy holding it together (It could be soldered, as the can is a copper alloy, but the heat might damage the plastic mount). Note that the capacitor case is not at chassis ground, so it is mounted with insulating washers. I added a wire to ensure that the case was properly connected to where it should be. The rebuilt capacitor looks like the original.

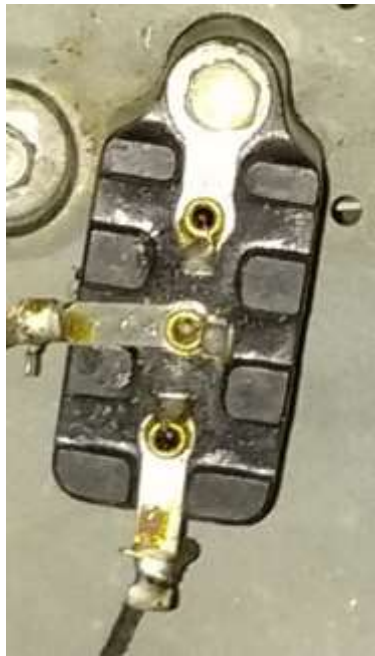
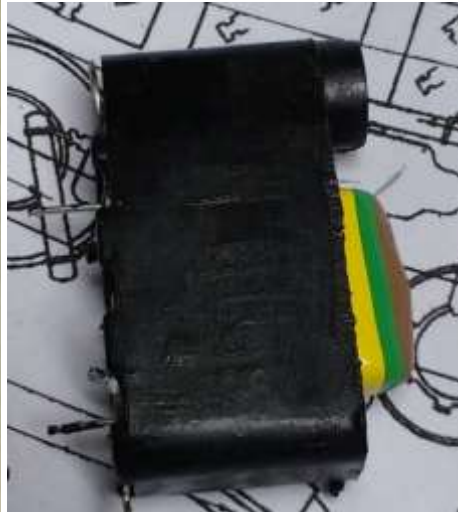
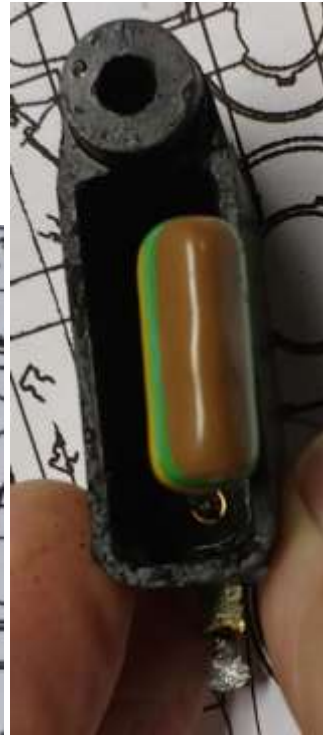
Restoring the paper capacitors. The modern capacitor is later pushed all the way in, making it invisible.

The paper capacitors in the “coffins” were heated in a barbeque (to keep the nasty smell outdoors) on a sheet of aluminum foil until the wax melted and the contents could be removed. In fact, this took surprisingly little heat. Modern 630V capacitors fit neatly inside the resulting coffin.
