Repairing a Ducretet Radio

Gord Rabjohn

December 2019

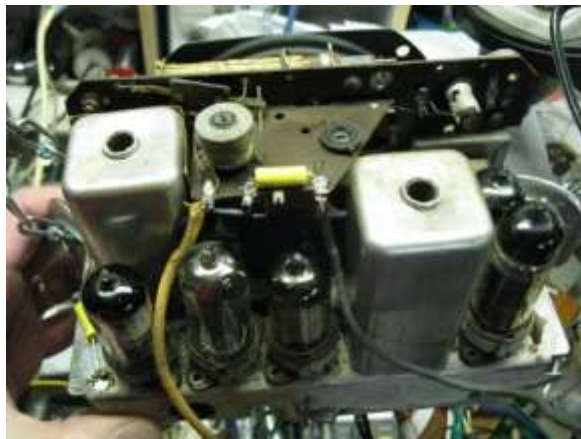
The radio is very compact inside, with parts quite close together. However, the IF transformers are enormous, more like the size one might find in a radio from the 1930's. There is no variable capacitor; tuning is accomplished with ferrite rods that slide inside coils (one for the antenna, one for the oscillator). This is referred to as “permeability tuning”, and is often used in car radios, though car radio designs that I have seen are much more “rugged and solid” than this radio. It is a 2-band radio featuring a long wave band in addition to the usual Broadcast Band. Tuning all the way to the end of the band flips the band-select switch. This does not seem to work very well.

Figure 2: Top of chassis. Note huge IF cans.

Digging further, I found that the IF transformers were not tuned correctly. These were tuned with ferrite slugs, and the ferrite slugs were held in with glue or caulking that had come loose, and in fact one of the slugs was missing. The slugs did not “stay put” in the IF transformer, there was nothing in there to grip the threads. I took the transformers apart (which was probably unnecessary but I wanted to make sure they were intact inside). I wedged a piece of insulation between the slugs and the inside of the IF coil form, and that kept the slugs in place and allowed me to tune them. I had to whittle a tuning wand out of wood for the three original slugs because I did not have any non-metallic tools for this rather large slug.

I wanted to verify that the IF transformers worked. To do this, I attached an RF generator directly to the primary (the generator has such a low impedance that it kills the “Q” of the parallel-tuned primary circuit), and an oscilloscope via a high impedance probe to the secondary. The secondary slug was tuned until the peak response as seen on the oscilloscope was at the right frequency (in this case, 472kHz). The primary slug had little effect. I repeated the above exercise with the primary and secondary swapped to tune the primary slug. If the transformer and associated capacitors are working, the response will exhibit a pronounced peak over a very narrow bandwidth. Note that these slugs will have to be retuned once the IF transformers are returned to the circuit because the stray capacitance will be different.

Making a long story short, I removed and retuned both of the transformers, replaced the missing slug, replaced them into the radio, and found that the radio came alive. I believe that the last person who attempted to repair this radio was fooled by the dud coupling capacitor and tried to tune the IF transformers in a last-ditch attempt to get it to work.

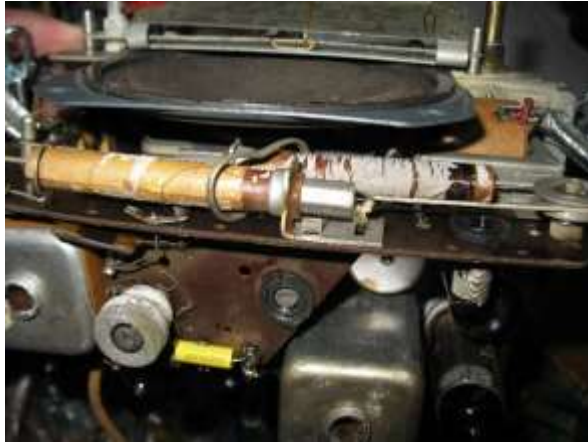
Figure 3: Permeability tuning

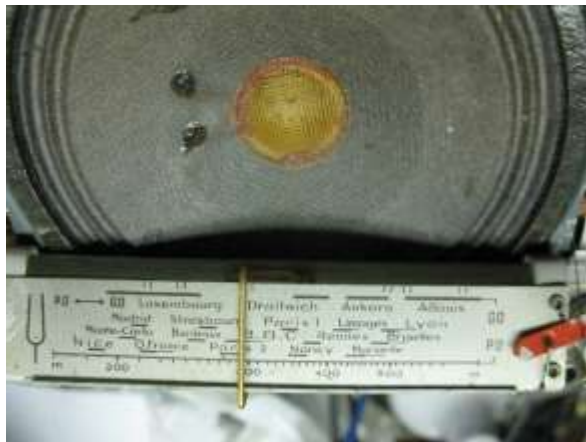
Figure 4: Slide-rule Tuning

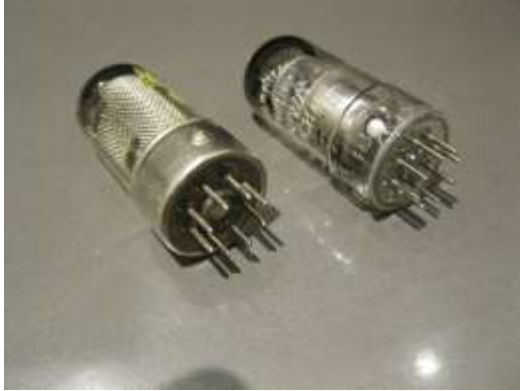
Rimlock tubes are miniature tubes made with 8 evenly spaced pins. They look similar to 7- and 9- pin miniature tubes that we are familiar with, but the socket indexing is done with a protrusion on the side of the tube's base that lines up with a slot in a rim that surrounds the socket in the chassis. A big advantage over miniature tubes is that they can be inserted by "feel" (like octal and loctal tubes); to insert the tube, you can close your eyes and spin the tube in the socket rim until you feel the protrusion fall into the slot. The button base makes them work well at high frequencies. This type of tube is quite uncommon in North America, and is found only in imported sets. This particular radio uses a UCH41 converter, UF41 IF amp, UBC41 detector + first audio, UL41 audio output and UY41 rectifier. These filaments add up to 117 volts, and take only 0.1A, which makes them run cooler than the standard "All American 5" line-up. (There is a 0.1A American miniature tube line-up but it is fairly uncommon.) By the way, the OVRC tube stock has very few Rimlock tubes; if you have any extra, I welcome them! Generally, Rimlock tubes have a "4" as the first numerical character in the European tube number.

Figure 5: Rimlock tubes

The tubes in this radio exhibit "Filament Flash". The bottom part of the filament, the part between the heater pins and the cathode, lights very brightly upon turn-on. To me it is very disconcerting, because I imagine that this would reduce the life of the filament from thermal fatigue. It happens because the thermal time constant of the exposed filament is smaller (it heats up faster) than the rest of the filament. Tube filament's peak current when cold is about 3 times larger than the hot current because the filament resistance increases when it is hot. So, when most of the filament is still cold, the hot part gets even hotter (because the low resistance causes the current is higher than normal). Some tubes exhibit filament flash even when the filament is supplied from a constant voltage source, but series filament strings are even worse. It can be reduced by turning the voltage up slowly, or allowing a low current pre-heat time. I often see filament flash in series sets, but I think Rimlock tubes tend to be worse (the web thinks that European tubes are worse in this respect, which may be true). The wisdom of the web does not seem to be too concerned about this.
