Repairing a Sony TR-72 Transistor Radio

Gord Rabjohn, May 2020

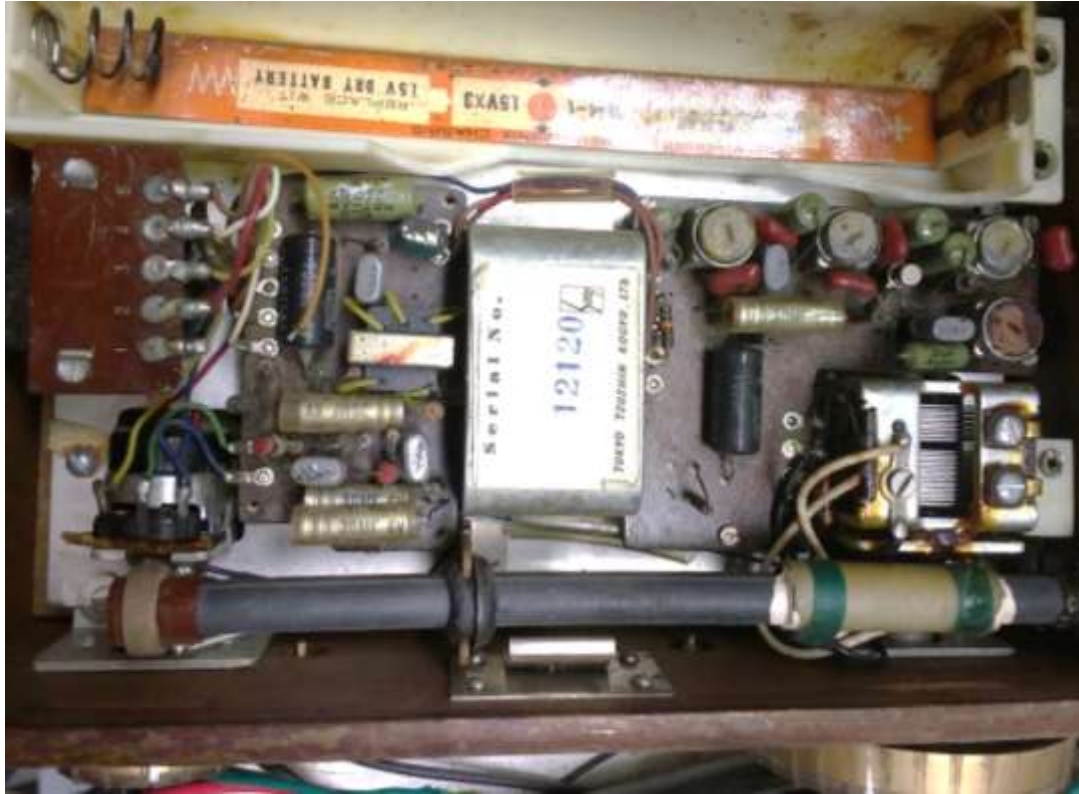
Figure 1 The radio (one output transistor was removed)

I acquired my TR-72 in the late 1980's from my Grandfather's estate, and it sat on a shelf until recently. It was fairly early in the production run, with a serial number 12120. My TR-72 is in rough condition, having suffered some external water damage. Inside, there was corrosion, a missing transistor (The RF/IF transistors have sockets, the first IF transistor was missing), and the usual grunge of age. See Figure 1. I powered it up slowly, and it took too much current. I quickly determined that one of the audio output transistors was shorted (using the clamp-on ammeter on the supply lines). Unfortunately, I had only one NPN germanium transistor in a case style that would look right in this radio, and I had already used it in the IF socket. These transistors are in a case style popular at that time (similar to TO-22, but you are forgiven if that designation is unfamiliar to you), and I did not want to put a modern-looking transistor in this radio. The output is push-pull, so one transistor cannot be replaced unless the replacement is very similar. So, I opted to replace both output transistors (and the associated bias diode) with standard silicon NPN transistors (2N3904) disguised as old transistors (I left the old transistors in the radio for future owners to appreciate).

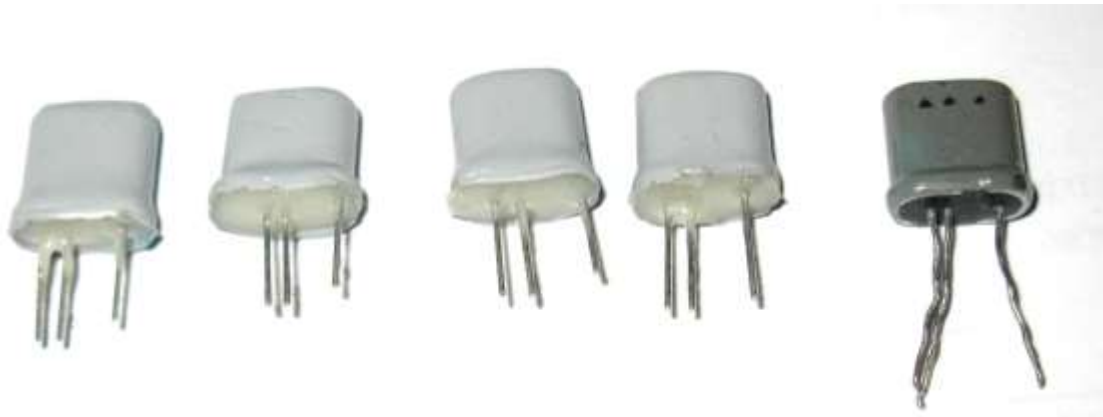
Figure 2 Four silicon transistors in disguise, and one original.

I used epoxy and a mold to disguise the modern transistors. I started by shrinking some heat-shrink tubing around one of the old transistors. I slid this tubing off of the old transistor, and this tubing became a little mold. I placed the smaller modern transistor in this mold and filled the mold with 2-part epoxy. When the epoxy hardened, I cut the mold off and trimmed off excess epoxy. Painting it grey results in a pretty good-looking replica. See Figure 2

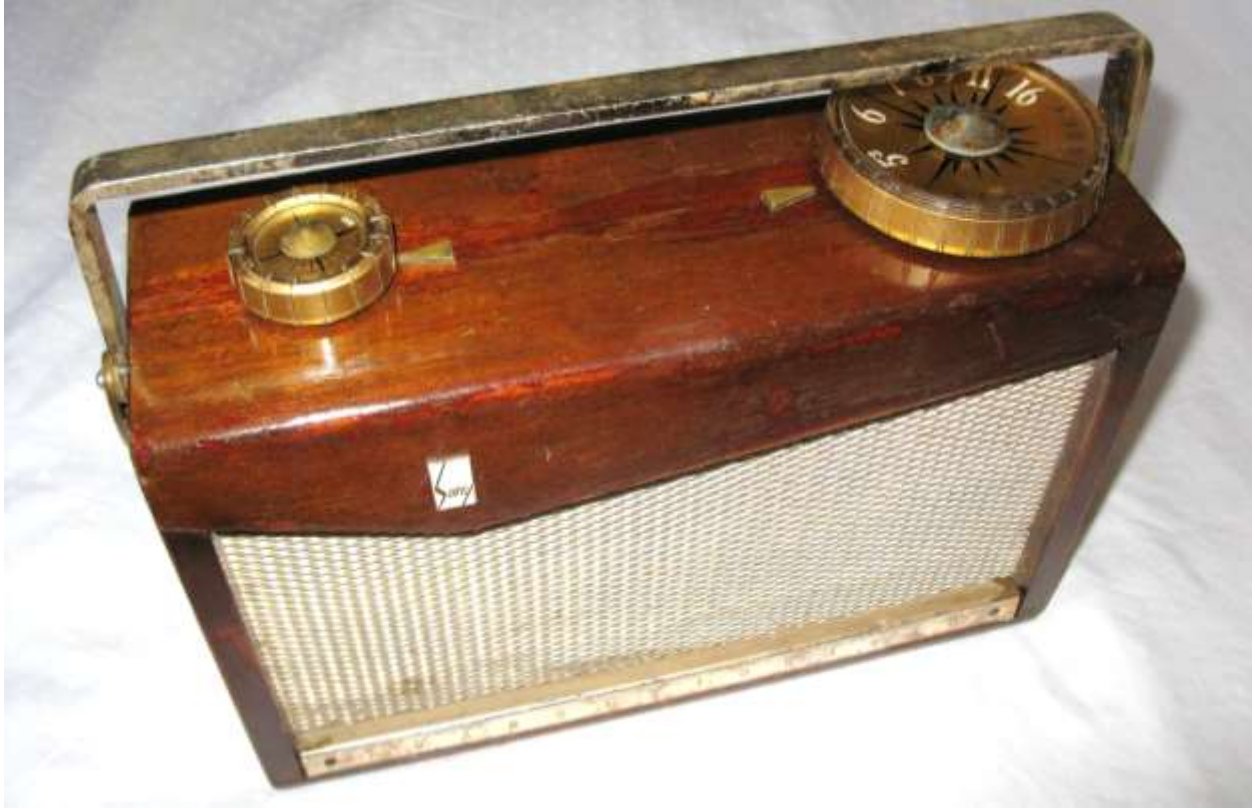
Figure 3. Sony TR-72 after cleaning up.

The varnish on the wooden cabinet was in rough shape, and parts needed gluing, so I re-glued joints and lightly sanded and shellacked the wood. The metal had been varnished as well, and the varnish was flaking, but I left it alone. I had to fabricate a latch for the back door. There is quite a lot written about this radio on the web and I refer interested readers to the references.
